Residential Report

111 and 131 Doolen Ct, North Palm Beach,
FL 33408

Lake Colony Apartments Three
Phase One Milestone Inspection and Reserve study

PHASE ONE MILESTONE INSPECTION AND RESERVE STUDY

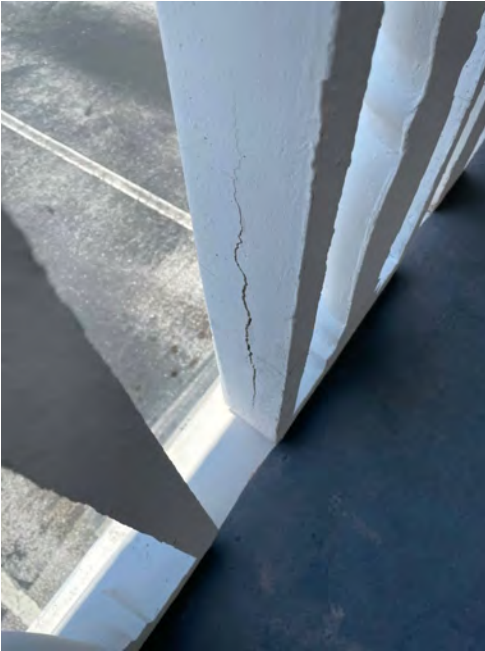
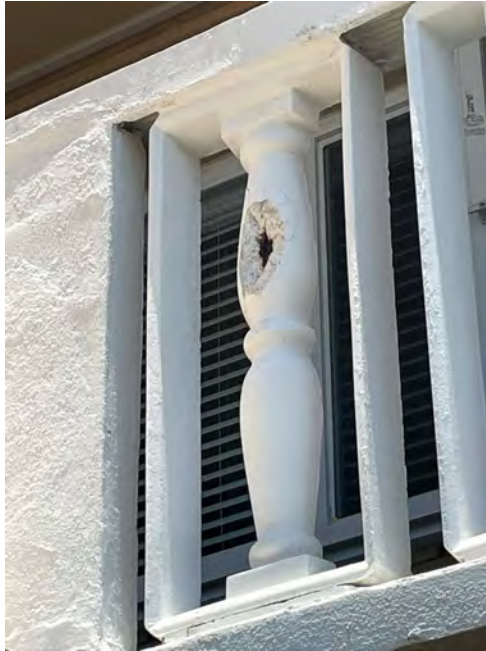
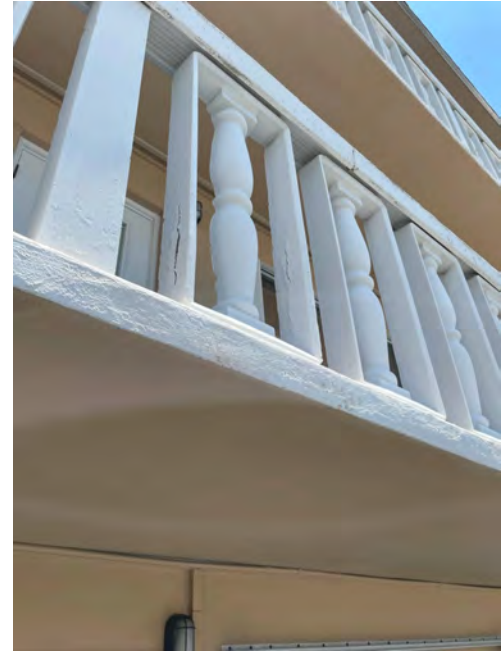
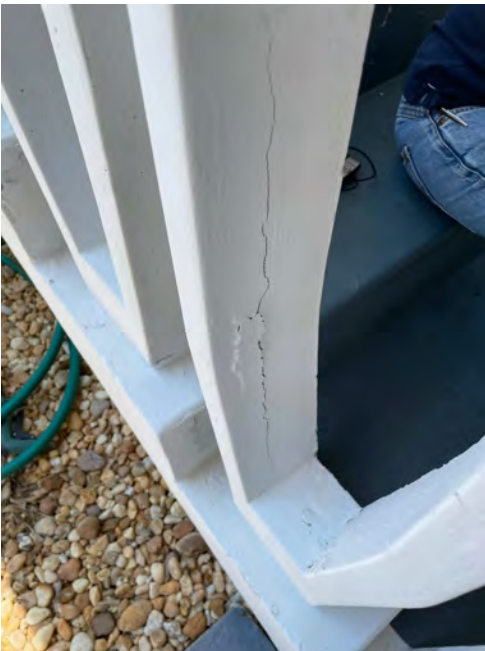
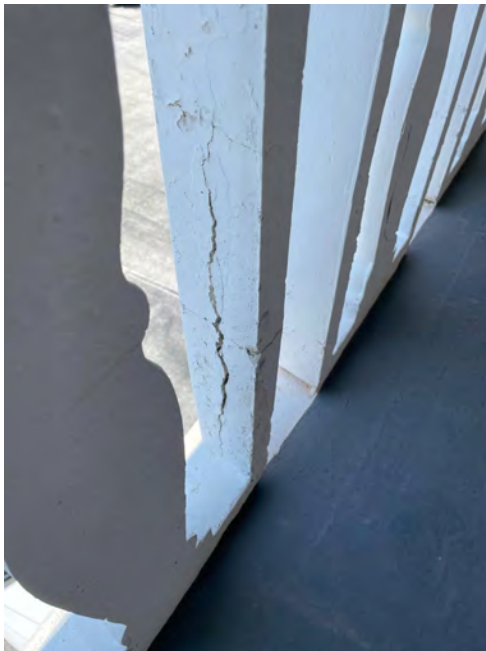
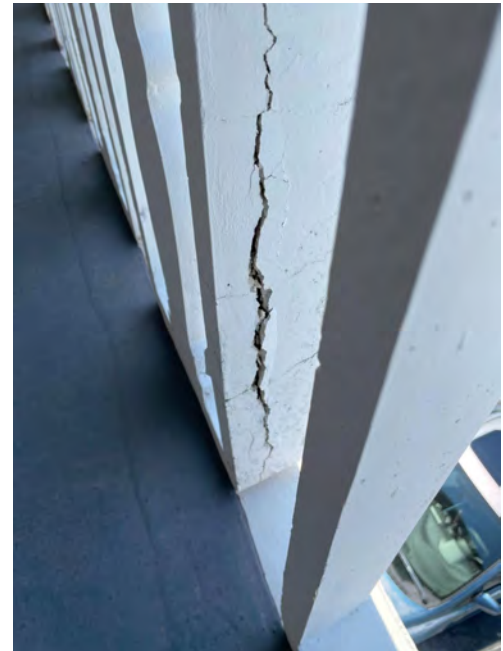
Item o.1

1. The concrete railings (hand rails and risers)all around the walk ways and stairs have cracking in them and need to be repaired.
2. Stucco ceiling at the 3rd level left of the elevator failing and needs repair.

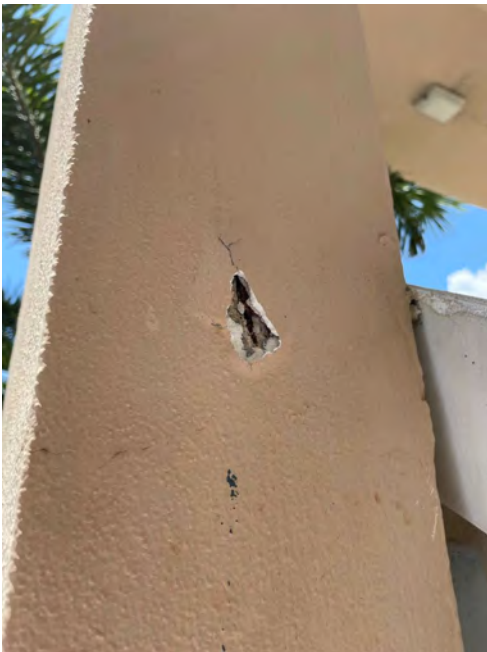
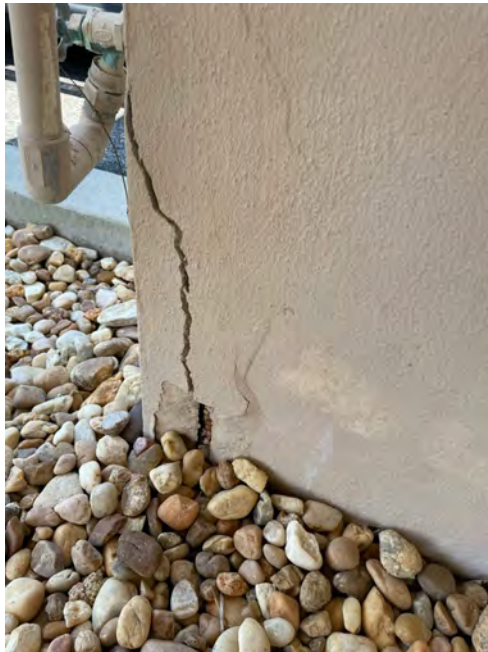
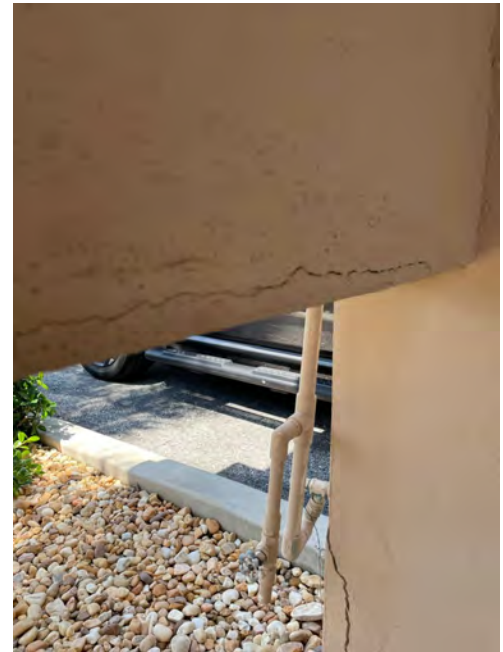
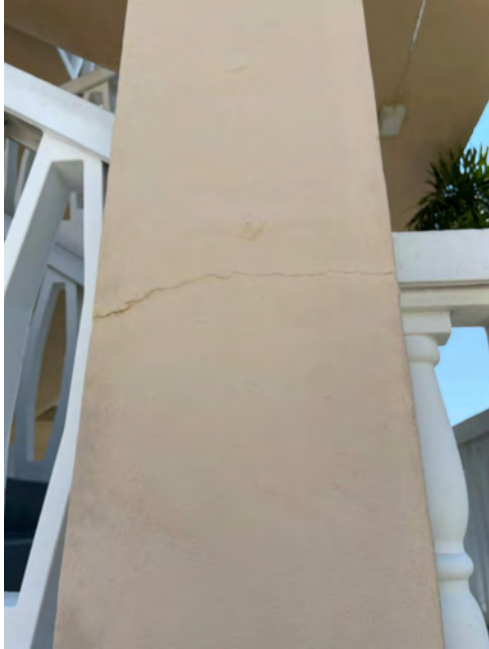
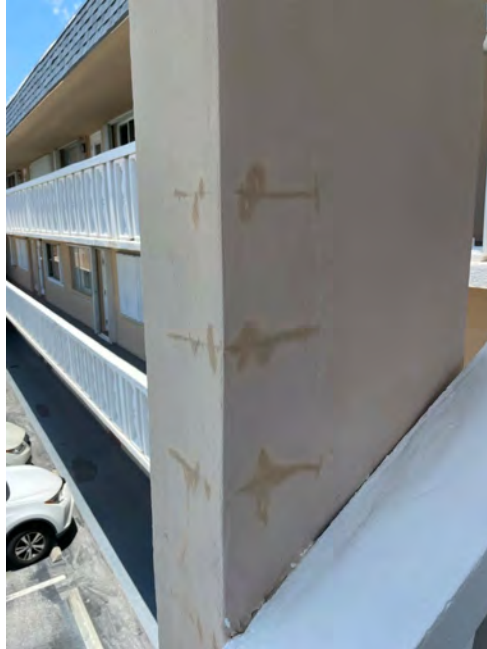
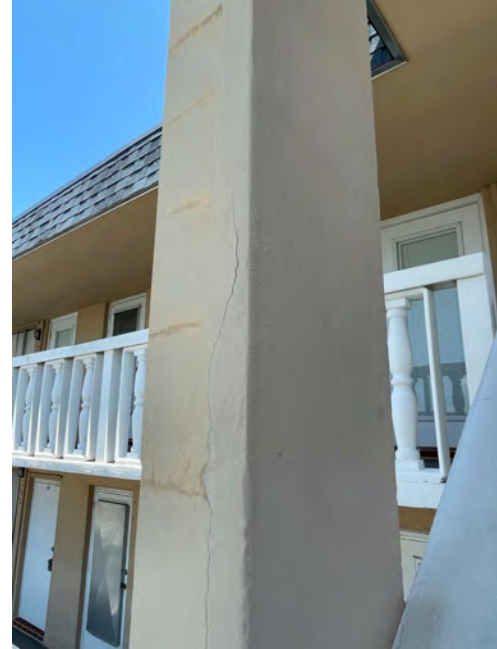
Item o.4

3. Several exit signs an all levels do not operate and need to be replaced.
4. The stair well columns and beams exhibit spalling and exposed rebar in several areas and need to be repaired.

Cracking and spalling at the stair well columns and beams, including the bottom of the cast stairs.

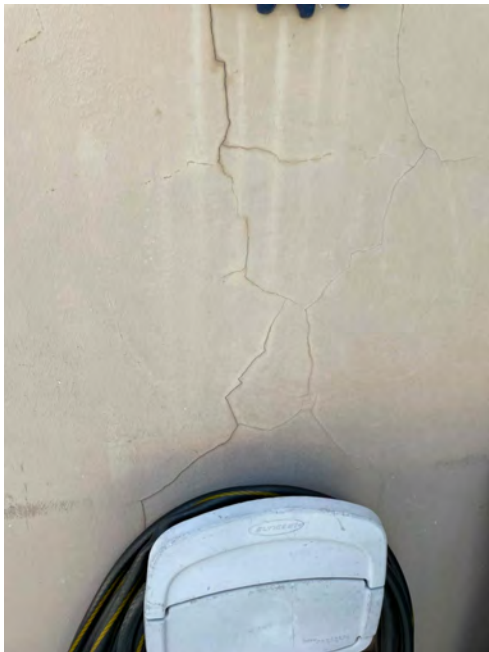
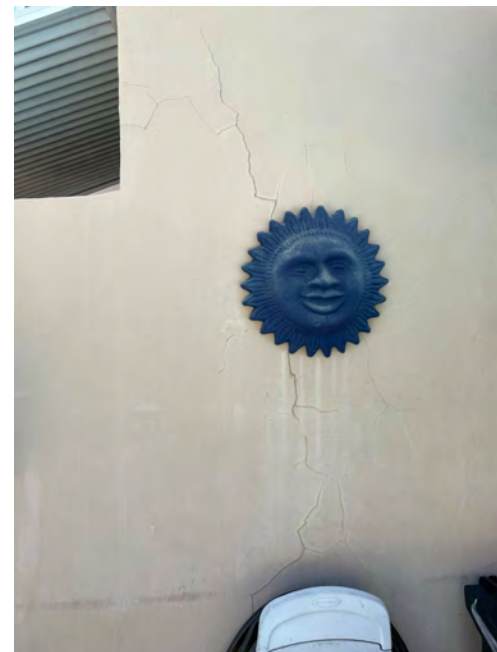
Item o.5

5. Cracking at pool wall on NW corner needs to be repaired.
6. Crack in floor in pool shower area needs repair.
7. Demising walls at back of building have cracks and spalling and need to be repaired.

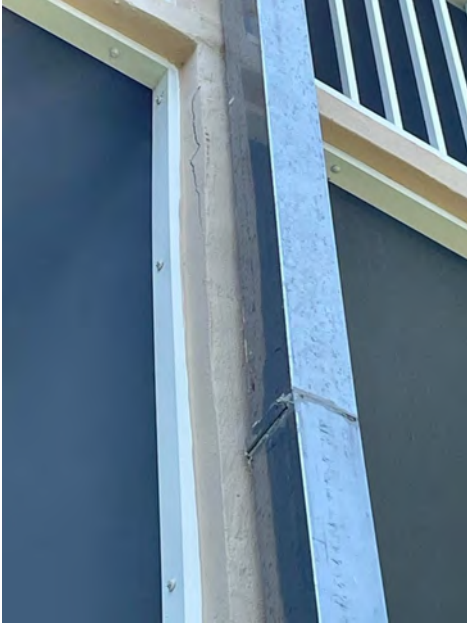
Item o.7

Noted cracks were fine with the exception of the one on the back demising wall which is wide and requires immediate repair.

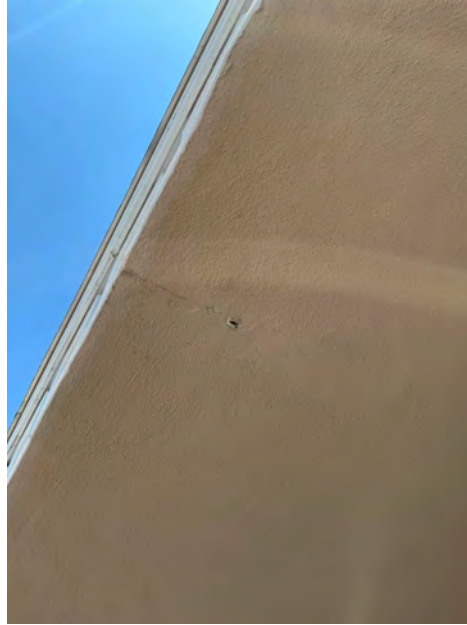
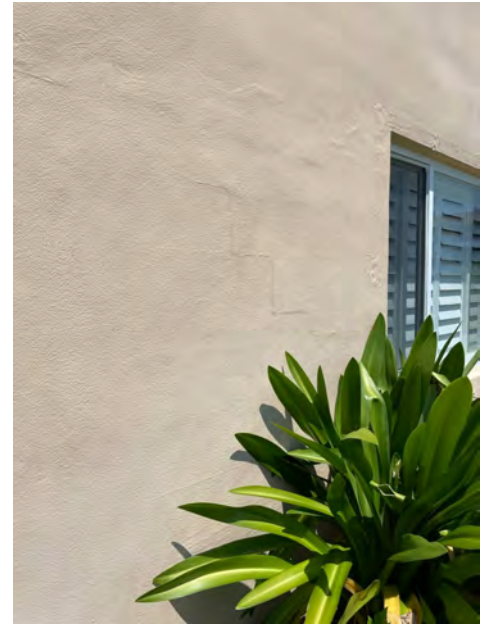
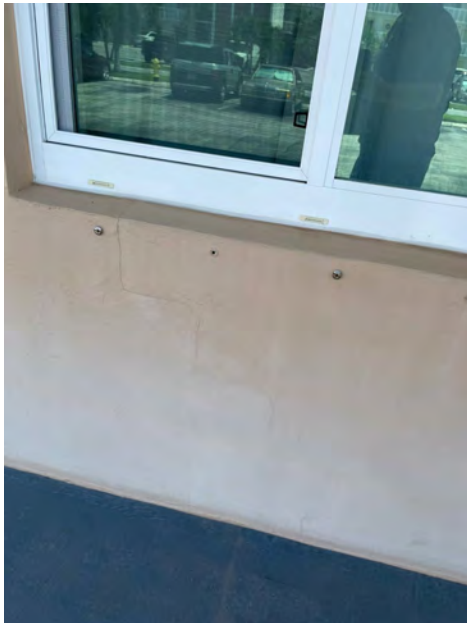
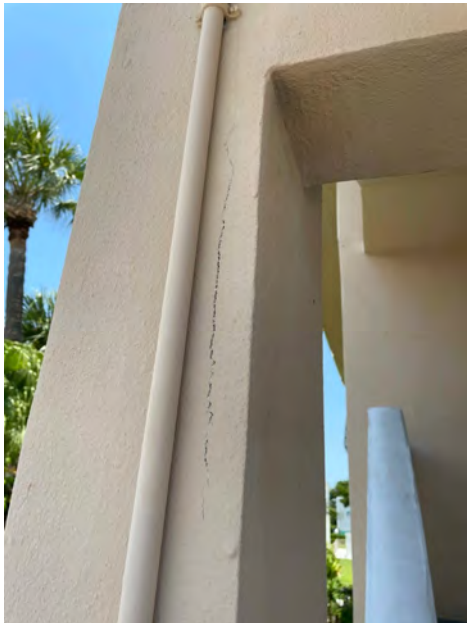
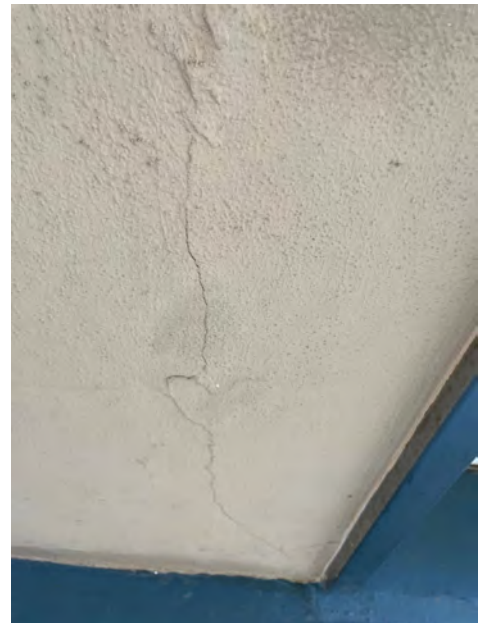
Item o.8

8. There is general fine cracks in the walls and ceilings all around the building that need to be resealed and painted.
9. Cracking on corner of back cantilever patio slab 3rd level needs to be repaired.

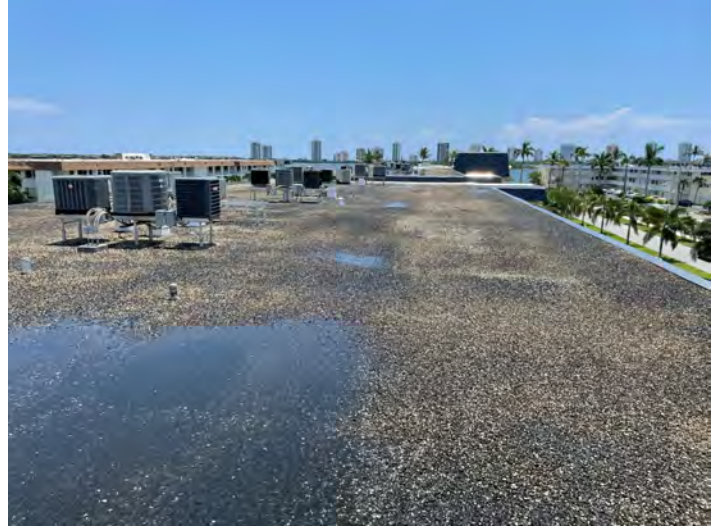
Item o.10

10. Roof will need to be replaced, there are signs of leaks in some of the upper floor units.
11. Spalling and rebar exposed on 2nd level flat roof above equipment rooms at the elevator stack needs to be repaired.

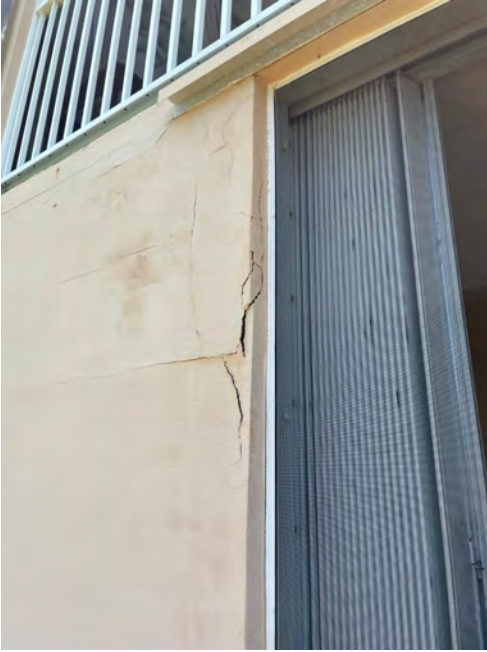
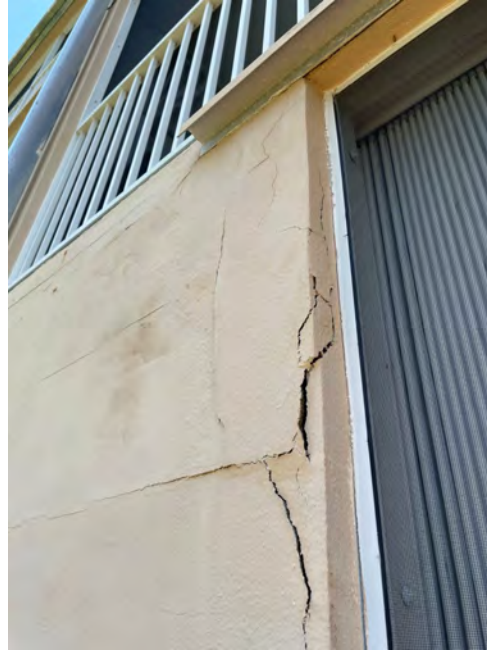
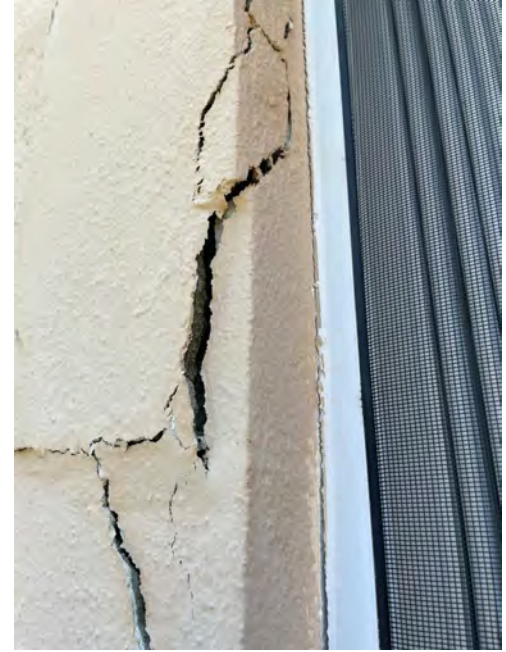
Item o.12

12. Large crack and spalling on back of building needs immediate repair.
2. Required (describe and indicate acceptance)
All repairs above are required and need be inspected by a county inspector or a PE after repairs are made
